PeakVue Technology Detects Damaged Bearing and Keeps Cement Mill Running

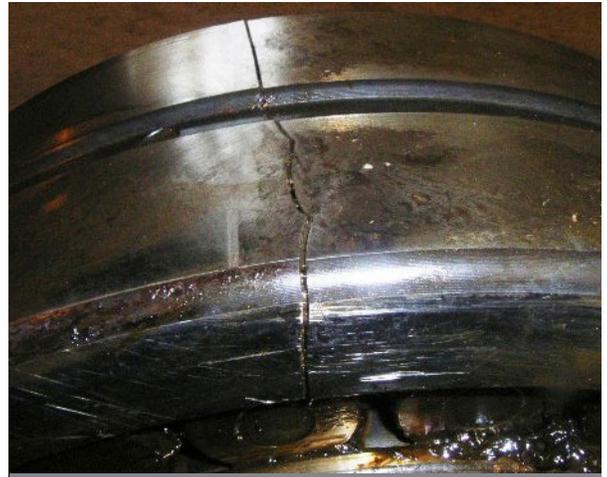
Data gathered in early 2010 revealed a condition involving a spherical roller bearing in cement mill 7 that warranted closer evaluation. However, nothing unusual could be seen in a view of the axial vibration at the inboard bearing of the left pinion gear. Two weeks later, additional PeakVue measurements provided the first indication of a serious problem.

Analysts at the mill used multi-spectra views to follow and evaluate the development of the bearing fault, confirming its severity and pinpointing its location. Based on this data, mill management decided to stop production to replace the bearing, knowing that the repair would take up to 12 hours. This action precluded a sudden failure that might have caused additional damage and taken much longer to repair.

“When inspected, the outer race of the bearing was cracked and flaking. It was only a matter of time before this part failed during normal operation.”
