Fisher High Pressure Valves with Cavitrol™ III Characterized Trim Reduce Upgrade Costs by \$140,000 USD and Extend Maintenance Time Interval from 2 Years to 4 Years

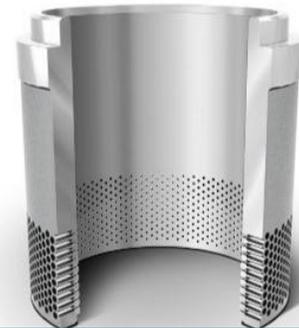
The Cavitrol III cage has specifically shaped holes, spaced diametrically around the cage circumference. These holes reduce fluid turbulence, dissipate fluid pressure, and help increase flow capacity.

After proper valve sizing and selection, the Emerson sales office in Japan, recommended the use of a Fisher Cavitrol III characterized trim. The Cavitrol III cage has specifically shaped holes, spaced diametrically around the cage circumference. These holes reduce fluid turbulence, dissipate fluid pressure, and help increase flow capacity. In this case, the cage is characterized, which meant that it was designed to comply with the process conditions to improve the flow control of the valve.
